SEWAGE UPDATE

Over the past 2 weeks we have had three successive sewage breakouts on the main sewage line between the Maidstone Rd Pumping Station and its eventual route past Whatcote Cottages and Askew Bridge to Wrotham Heath. These breakouts have all happened in a garden of a house on Sandy Ridge, and there is a major Southern Water operation taking place there. The proposed solution that we have been advised of today is that a 25 metre sleeve will be inserted in the damaged pipe to ensure sewage cannot escape again.

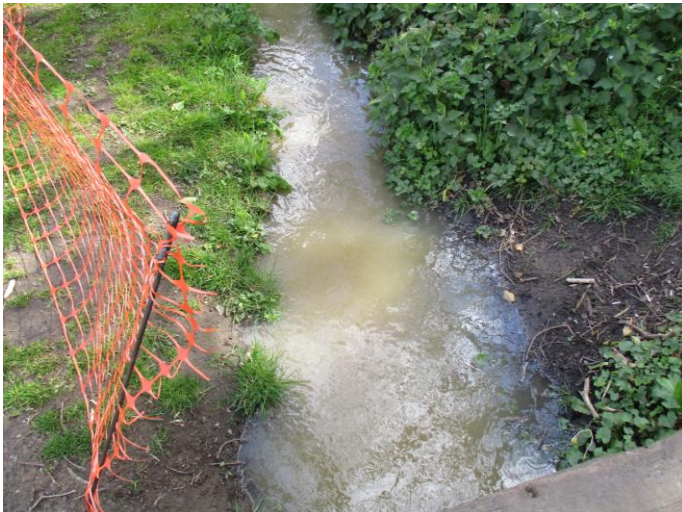
Recreation Ground Stream

The sewage has been overflowing into the Network Rail culvert that runs west alongside the railway line as far as Griggs Way, and thence through the Recreation Ground stream, heading through Valleyview Estate towards Basted Mill pond. So far judicious damming of the route has prevented a major flow into the river system. The Environment Agency have been kept informed and are monitoring progress closely.

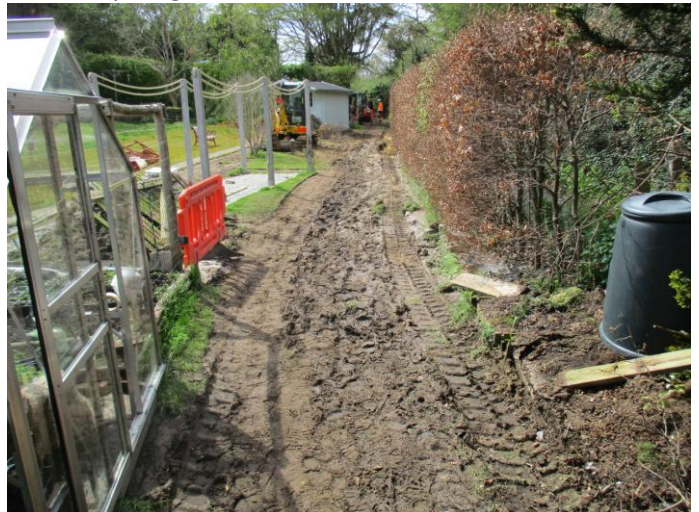
Sandy Ridge Site

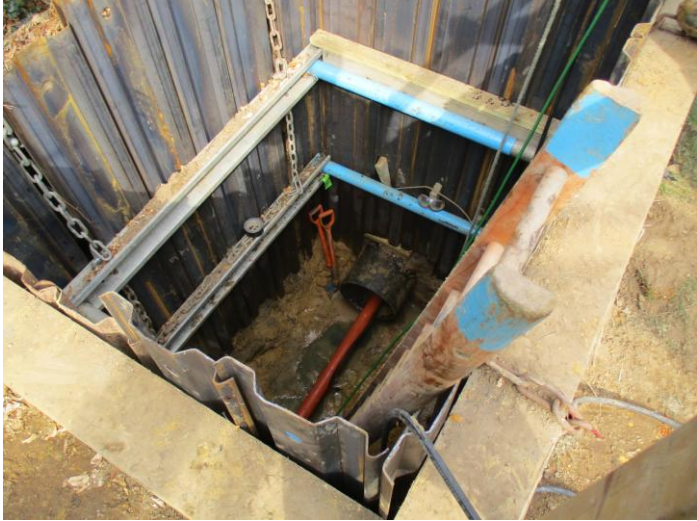
First Sandy Ridge Excavation

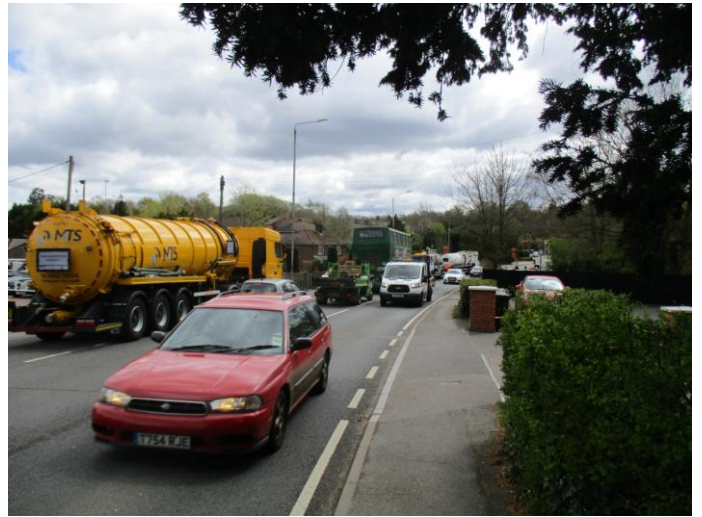
Tanker arriving at Maidstone Rd

The Maidstone Pumping Station has had to be shut down to allow work on the damaged pipe, and this has necessitated a huge fleet of sewage tankers bypassing the pipe running sewage from Maidstone Rd, Basted and Ightham.

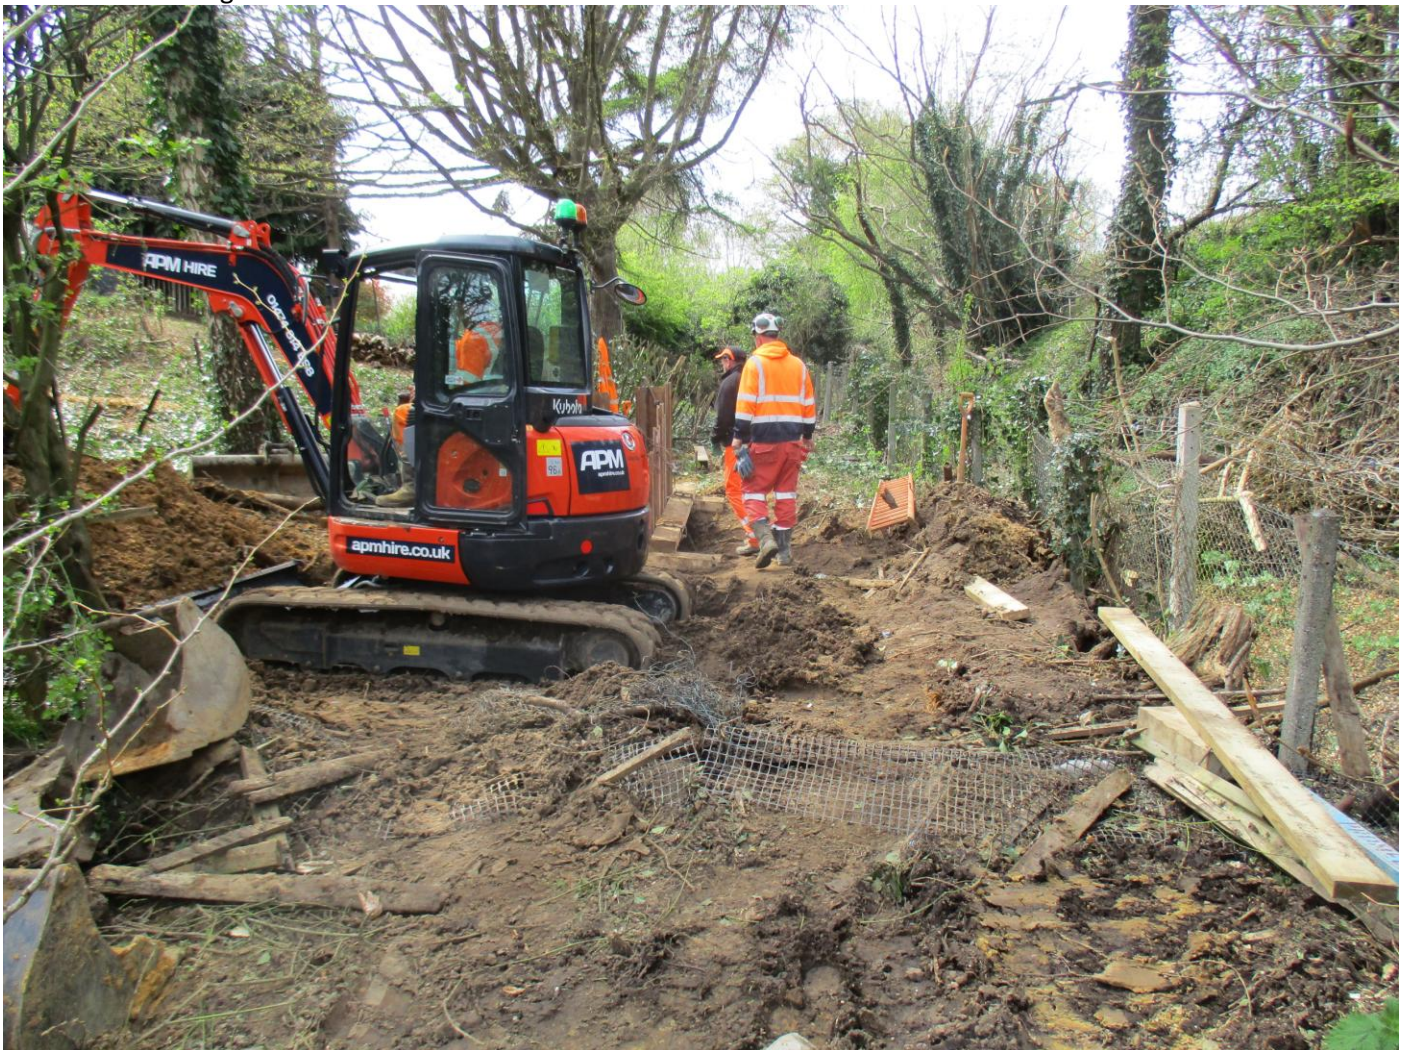
Site of third sewage breakout
